Quality Assurance and Source Inspection

Contract #: 04-0120F4Cty: SF/ALA Rte: 80 PM: 13.2/13.9File #: 69.28**WELDING INSPECTION REPORT****Resident Engineer:** Siegenthaler, Peter**Address:** 333 Burma Road**City:** Oakland, CA 94607**Report No:** WIR-018739**Date Inspected:** 17-Dec-2010**Project Name:** SAS Superstructure**OSM Arrival Time:** 700**Prime Contractor:** American Bridge/Fluor Enterprises, a JV**OSM Departure Time:** 1700**Contractor:** Zhenhua Port Machinery Company, Ltd (ZPMC), Changxing Island **Location:** Shanghai, China**CWI Name:** Mr. Zhu Zhong Hai.**CWI Present:** Yes No**Inspected CWI report:** Yes No N/A**Rod Oven in Use:** Yes No N/A**Electrode to specification:** Yes No N/A**Weld Procedures Followed:** Yes No N/A**Qualified Welders:** Yes No N/A**Verified Joint Fit-up:** Yes No N/A**Approved Drawings:** Yes No N/A**Approved WPS:** Yes No N/A**Delayed / Cancelled:** Yes No N/A**Bridge No:** 34-0006**Component:** Orthotropic Box Girder (OBG)**Summary of Items Observed:**

OBG TRIAL ASSEMBLY**OBG Segment 12AE**

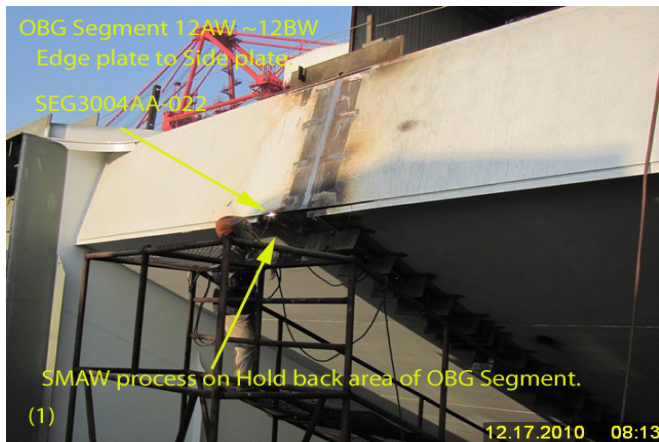
This QA Inspector observed ZPMC qualified welding personnel identified as 040656 Perform Shielded Metal Arc Welding (SMAW) on OBG segment 12AW+12BW Edge plate to Side plate hold back area. Joint identified as SEG3004AA-022 and CA3009-002. ZPMC QC Identified as Wang Zhu. The welding parameters as measured using QC's calibrated instrument appeared to be in general compliance with WPS-B-P-2214-Tc-U4b-FCM-1. For more information see below attached picture number 1.

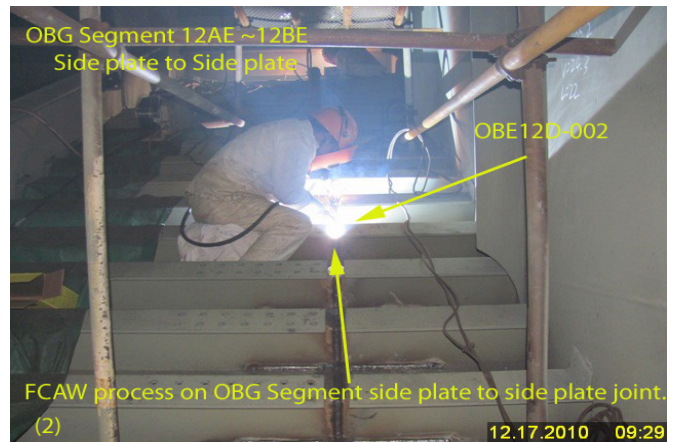
This QA Inspector observed ZPMC qualified welding personnel identified as 052763, 040367 Perform Flux Core Arc Welding (FCAW) on OBG segment 12AE+12BE Side plate to Side plate joint Cross beam side. Joint identified as OBE12D-002. ZPMC QC Identified as Wang Li Yang. The welding parameters as measured using QC's calibrated instrument appeared to be in general compliance with WPS-B-T-2231T-ESAB. For more information see below attached picture number 2.
